ONTARIO COUNTY LANDFILL
PROPOSED LANDFILL EXPANSION DEIS
VISUAL IMPACT ASSESSMENT
SITE 2

ONTARIO COUNTY, NEW YORK

TOWN OF SENECA

Figure Number
17

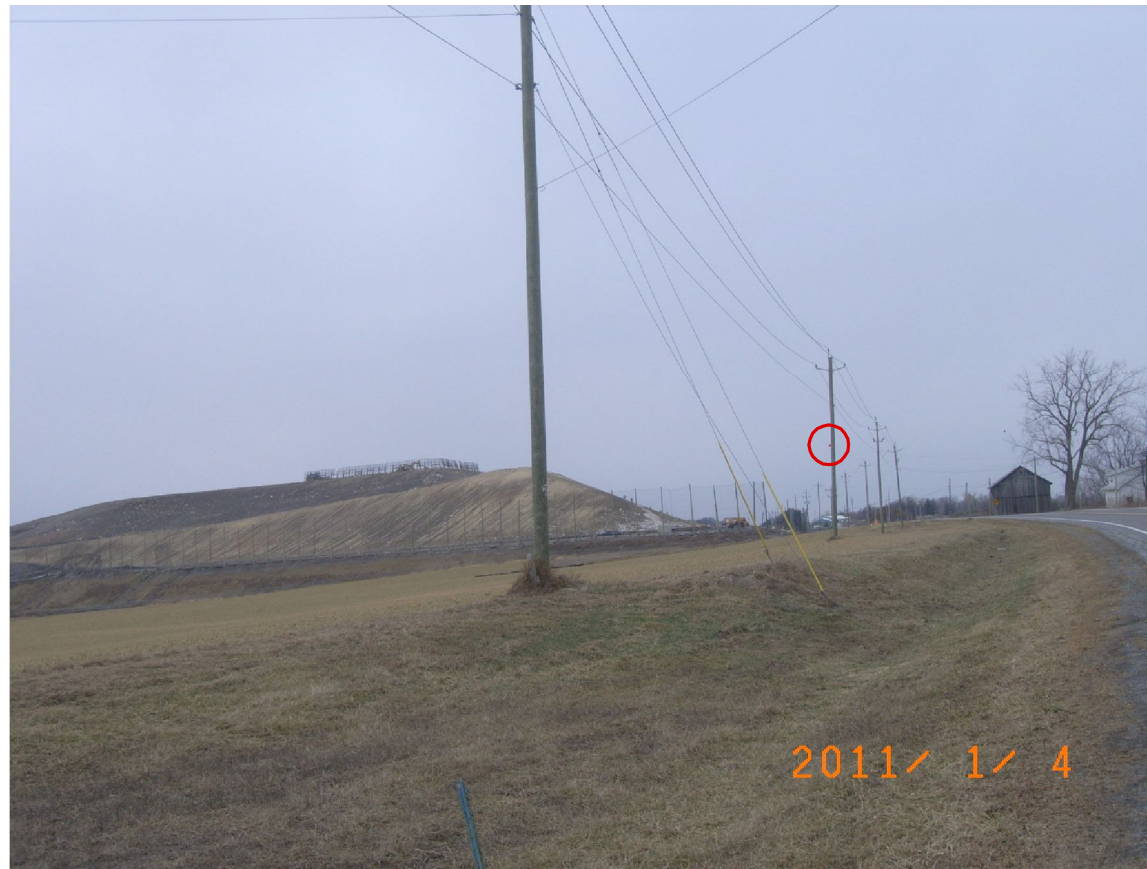
Existing Conditions as of 1/4/11 Balloon Location ○

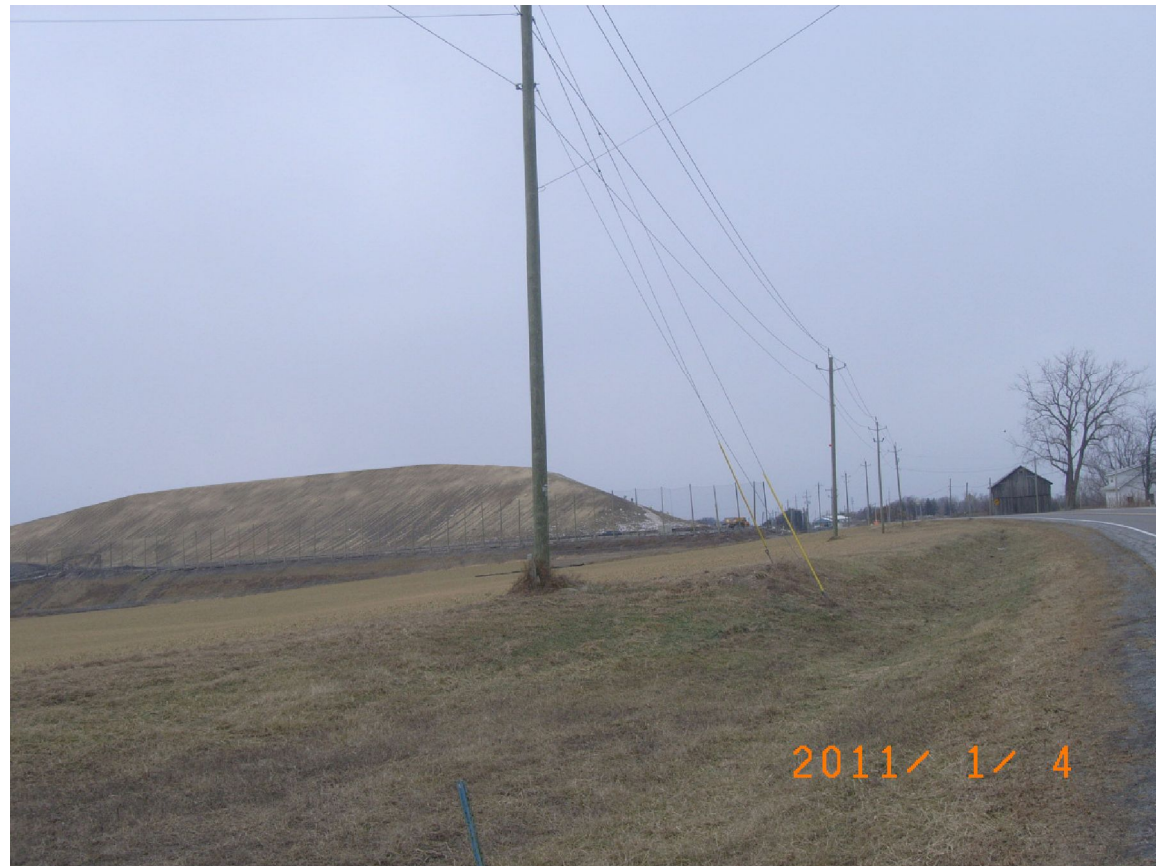
Currently Permitted Condition (997 Elevation)

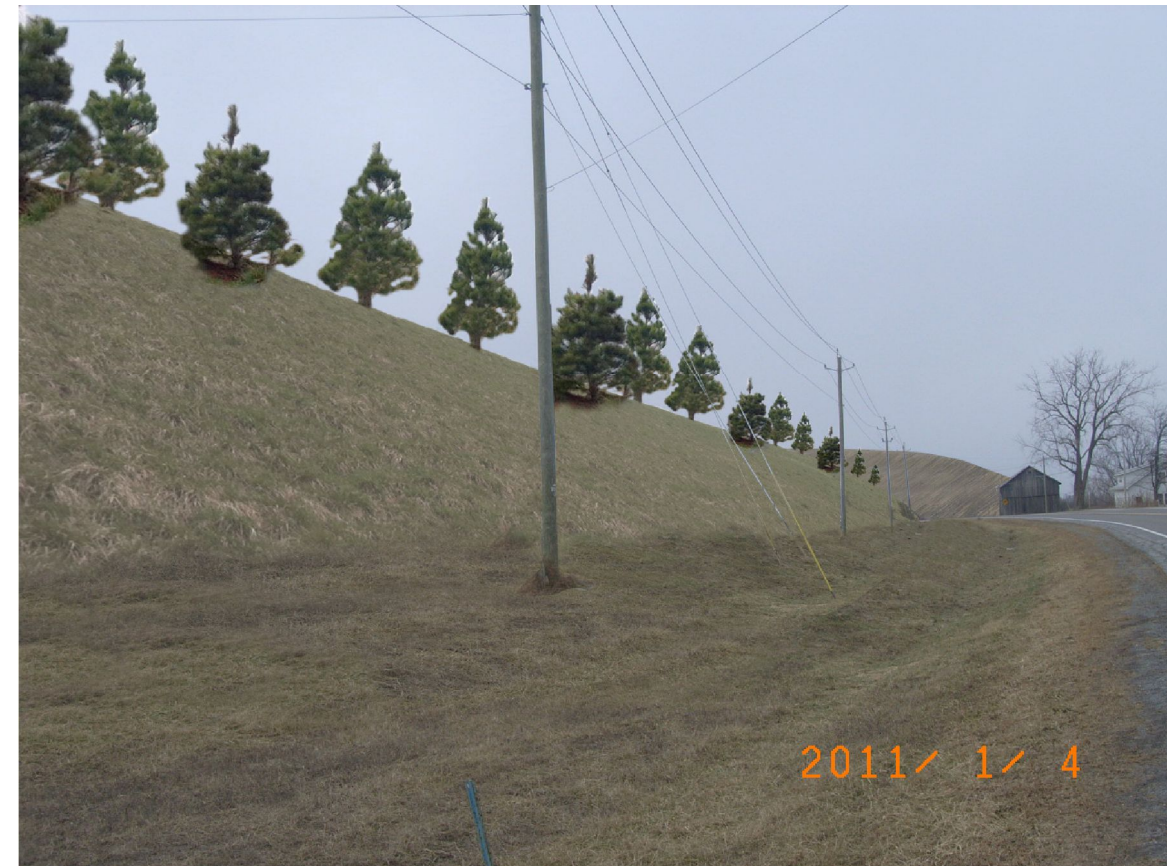
Proposed Permitted Condition (1025 Elevation)
